TECHNICAL MEMORANDUM

To: Brendhan Zubricki¹ and Dave Lash²
From: Candice Constantine, PhD, PE³ and Nick Nelson, CERP⁴
Date: August 17, 2022 **Project:** Alewife Brook Restoration
Re: Assessment Findings and Recommendations

This memorandum summarizes our assessment of hydrologic and geomorphic conditions from Chebacco Lake to approximately 2,500 feet downstream along Alewife Brook in Essex, Massachusetts (Figure 1). It provides a discussion of the challenges and opportunities associated with improving fish passage and flooding conditions and recommended strategies to address the problems.

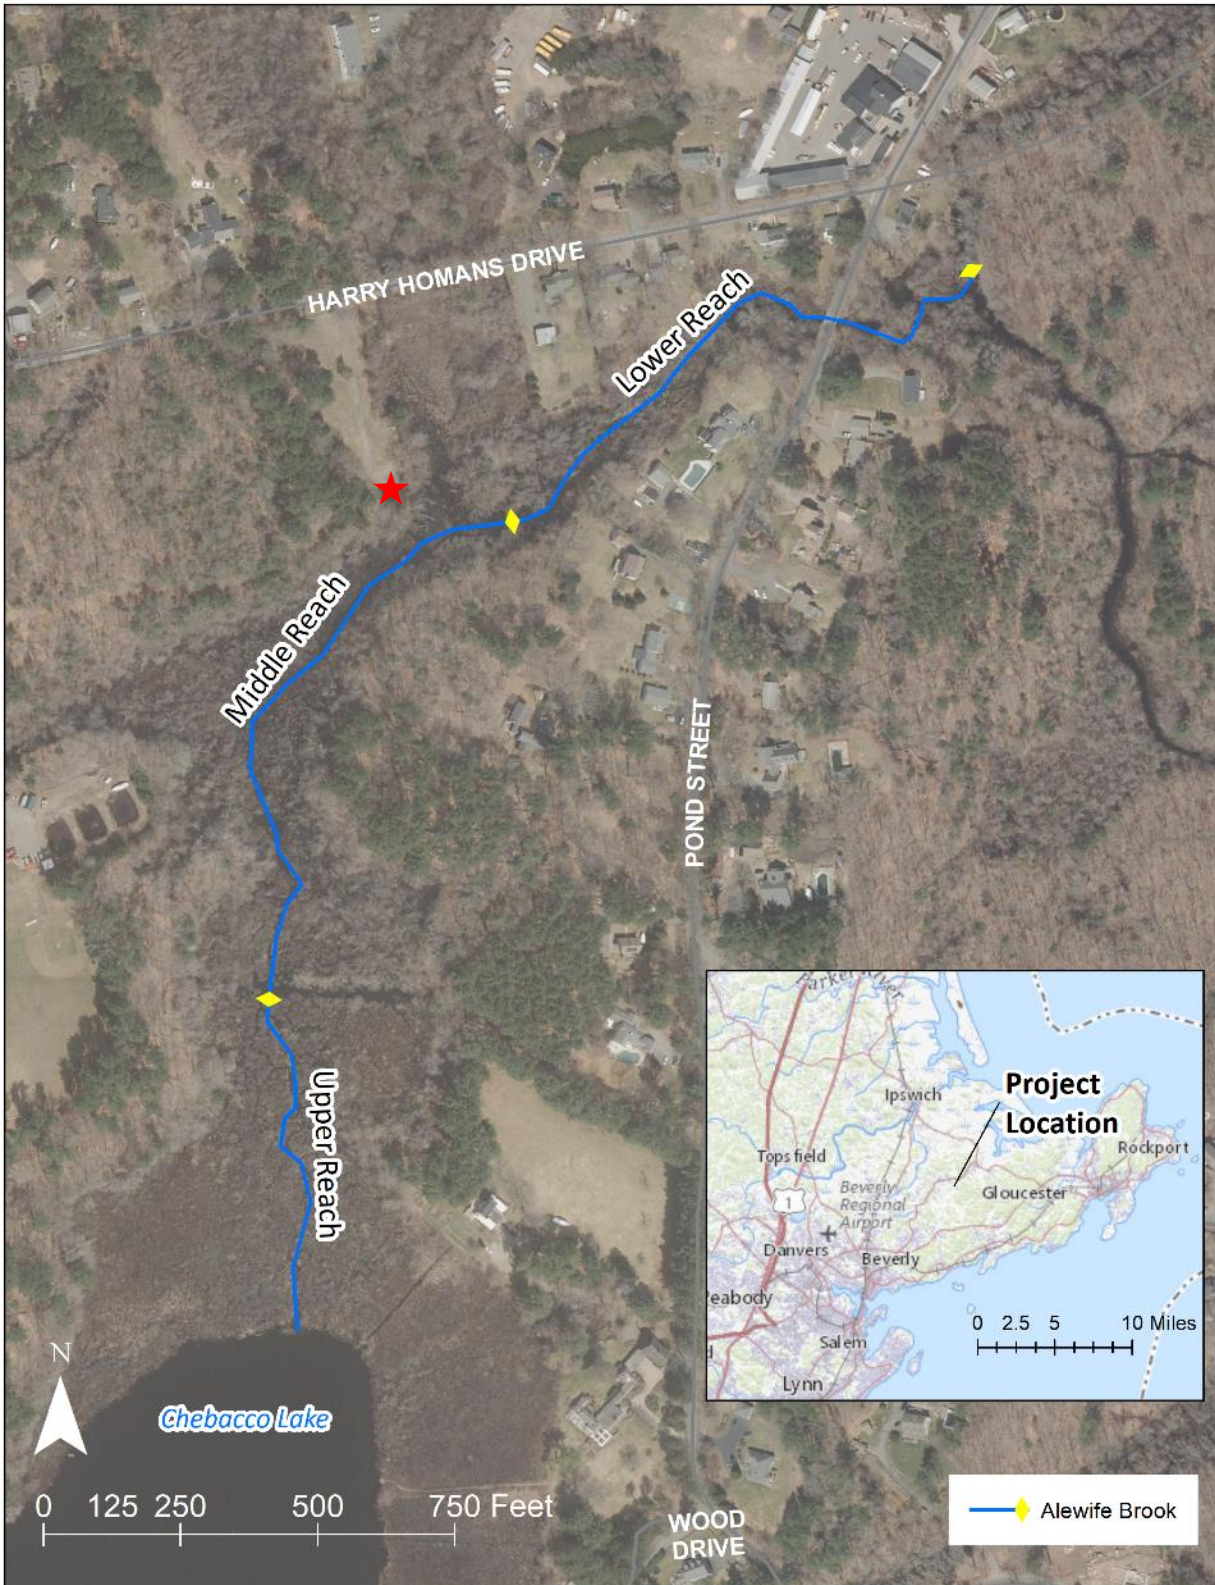
Figure 1. Alewife Brook in the study area. Flow is from south to northeast, originating in Chebacco Lake. The red star indicates the location of the Town wells. Project subreaches are labeled. Project location in regional context shown in inset. Orthoimagery and topographic map from USGS (2021).

The study area is broken into three reaches: the Upper, Middle, and Lower (Figure 1). The reaches were delineated according to geomorphic characteristics, which will be discussed in the following sections.

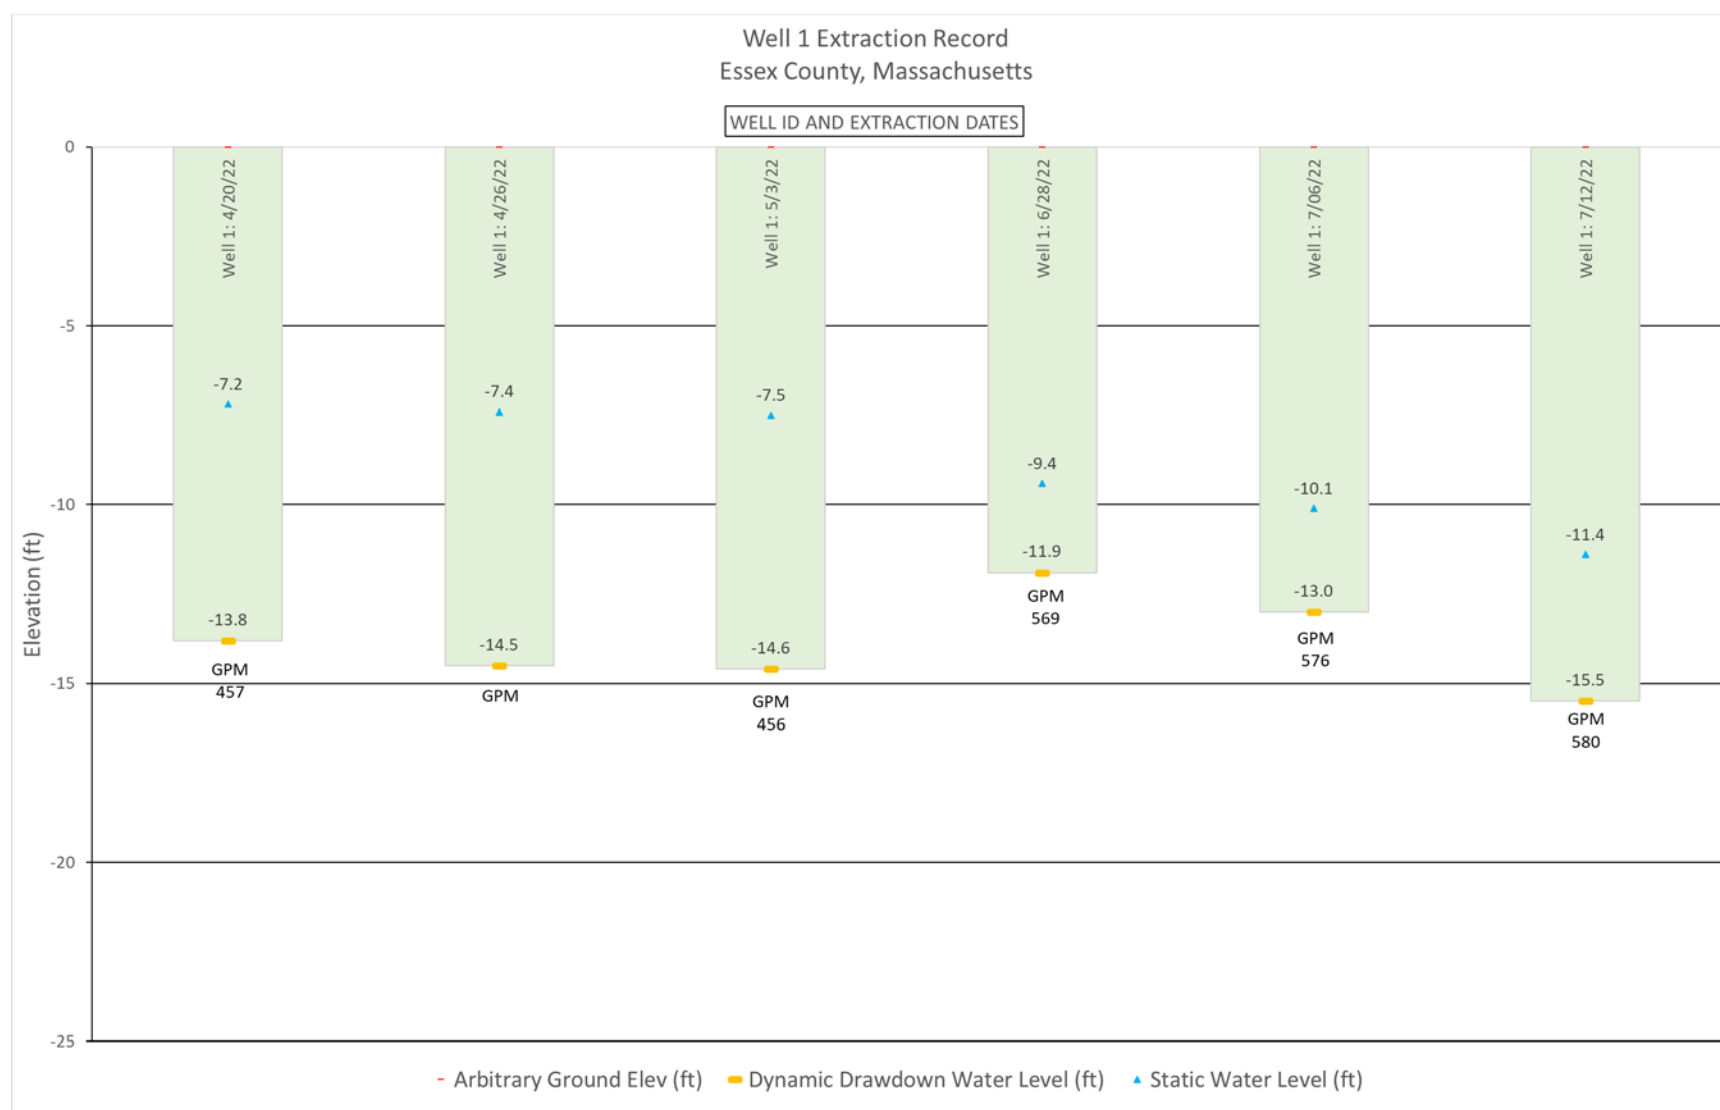
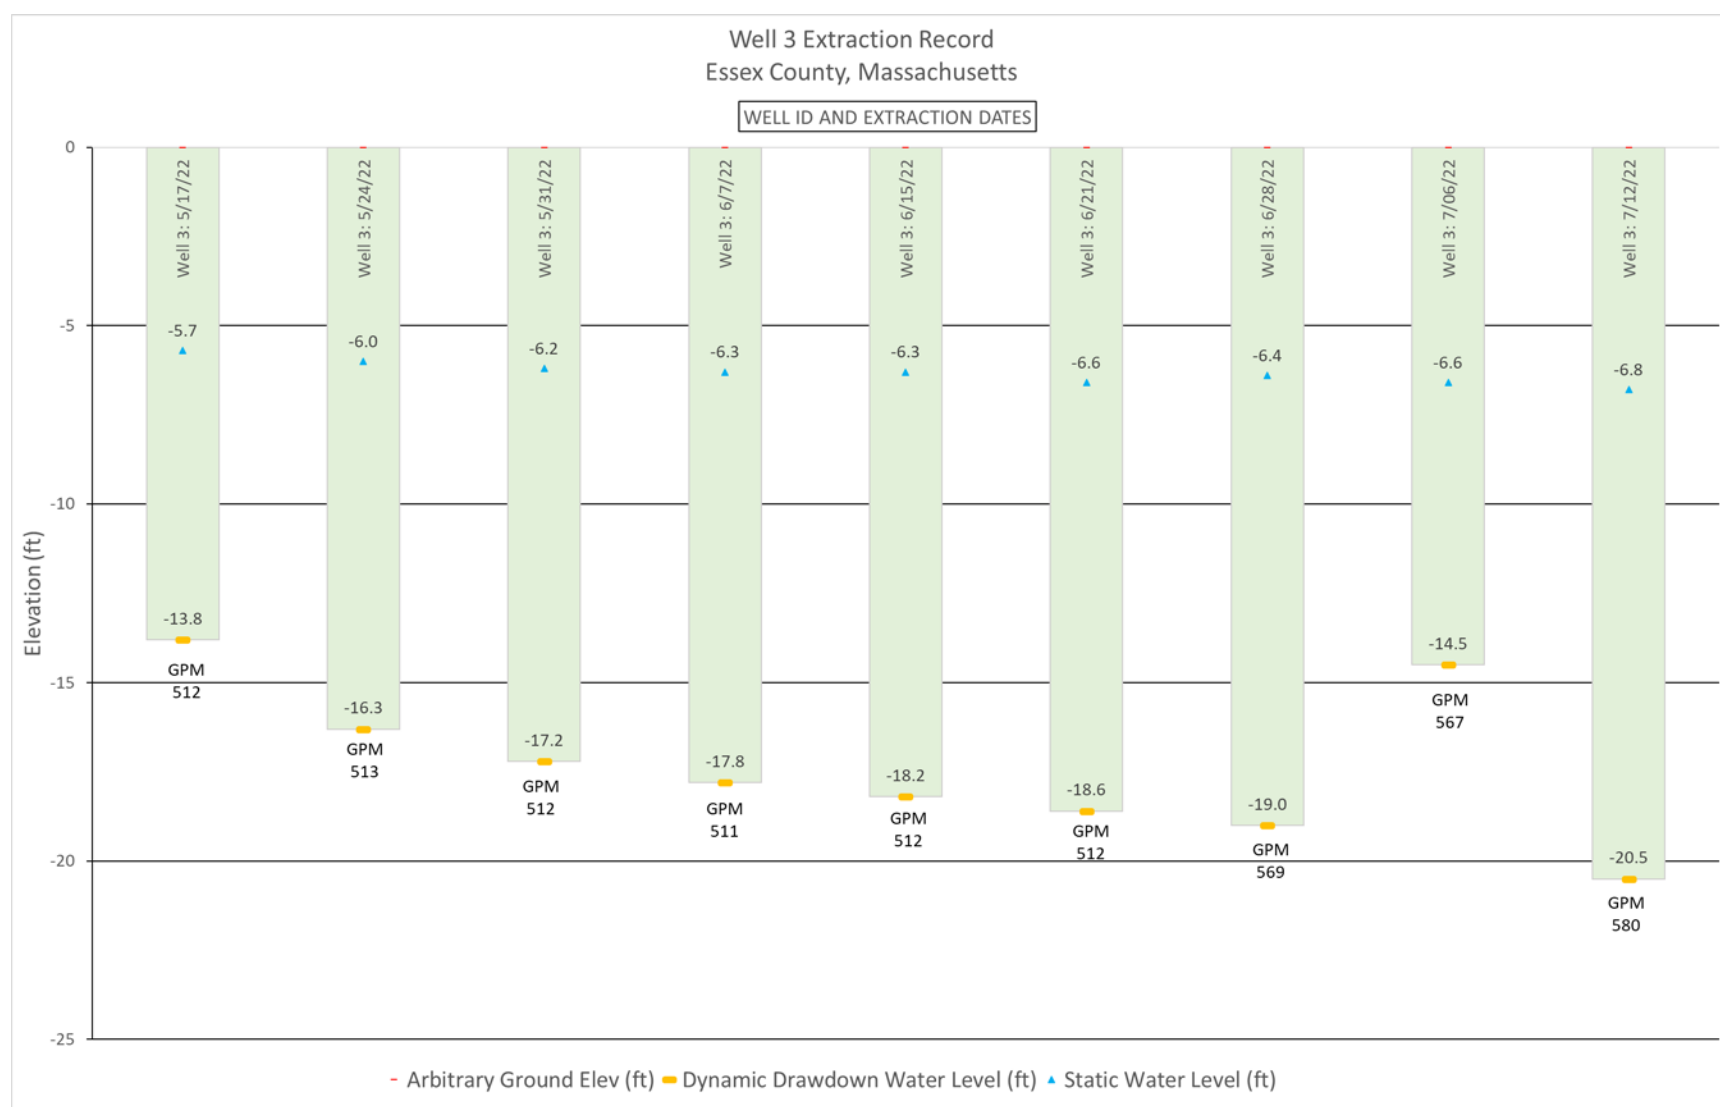
Well extraction data show exactly this trend. The data show that well extraction rates increased between April and July from approximately 457 gallons per minute (GPM) on April 20 to 580 GPM on July 12, with dynamic drawdown water levels¹¹ decreasing over this time. According to the Town, run times also increase as the weather warms such that total extraction volumes increase into the summer. The static water levels in the wells dropped 4.2 feet in Well 1, 4.3 feet in Well 2, and 1.1 feet in Well 3 over the same period, indicating a lowered water table through the study area with the greatest reduction nearest to Alewife Brook (i.e., at Wells 1 and 2). The data suggest that well withdrawals contribute to low flows in Alewife Brook in warm summer months; however, additional long-term groundwater and surface water monitoring and water budget analyses are necessary to determine what portion of the low water period in Alewife Brook is due to groundwater extraction versus seasonal hydrologic fluctuations, drought conditions, or other climatic factors.

Figure 9. Pumping rates (GPM = gallons per minute) and water elevations for Essex town Well 1 from April 20 to July 12, 2022

Figure 10. Pumping rates (GPM = gallons per minute) and water elevations for Essex town Well 2 from April 20 to July 12, 2022

Figure 11. Pumping rates (GPM = gallons per minute) and water elevations for Essex town Well 2 from April 20 to July 12, 2022

We reviewed the well data from Wells 1 through 3 from April 20 to July 12 (Figure 9, Figure 10, and Figure 11) and discussed operations with the Town¹⁰. The well pumps are generally operated starting in the morning until day-time demand is met and two underground storage tanks at the filtration plant are filled. The storage tanks serve as the supply through the night until pumps are started again the next morning. Run times and pump rates are lowest during wet periods and highest during hot, dry conditions when demand for watering lawns and other needs are greatest.

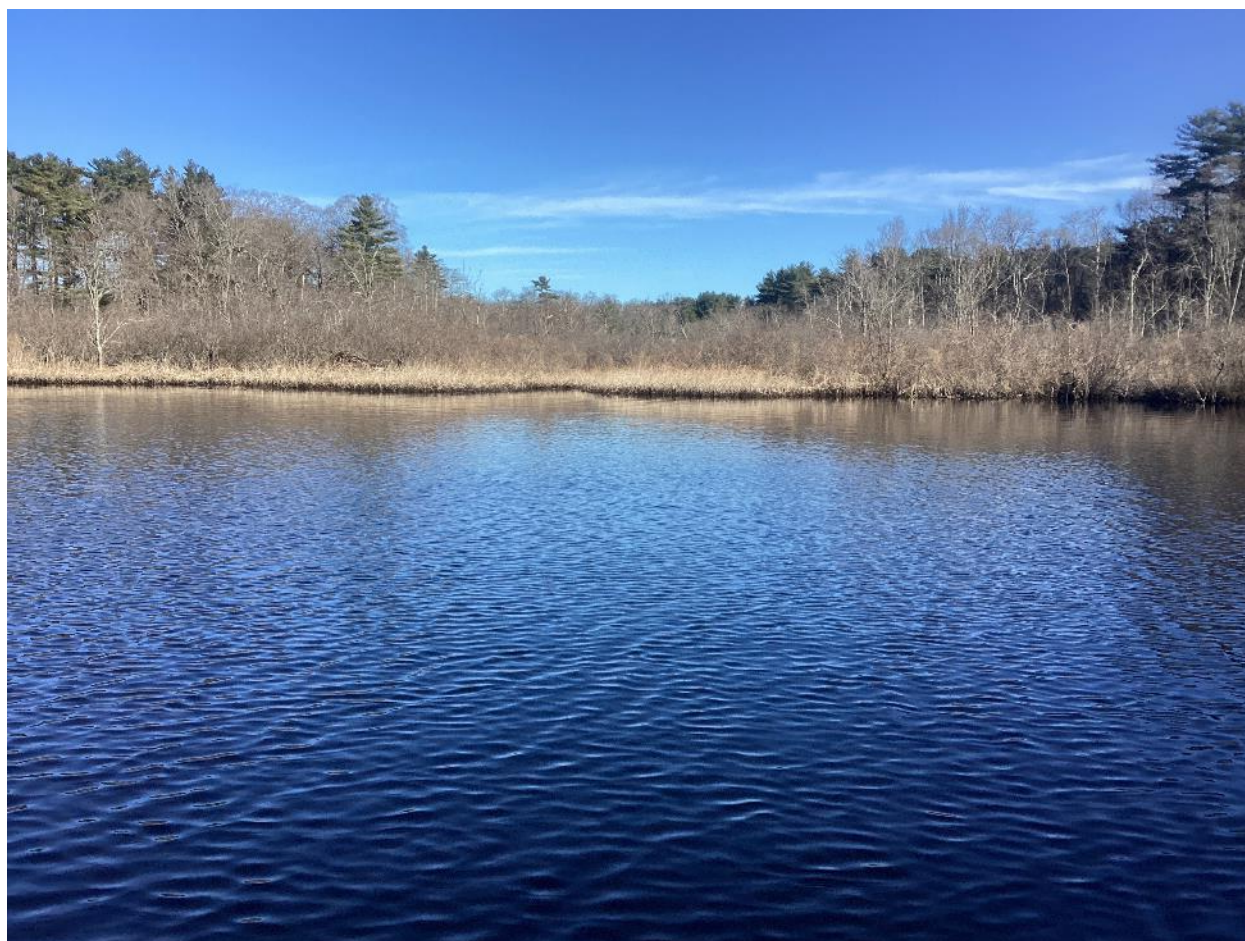
Figure 12. Looking north from Chebacco Lake toward the lake outlet. Photo taken March 23, 2022.

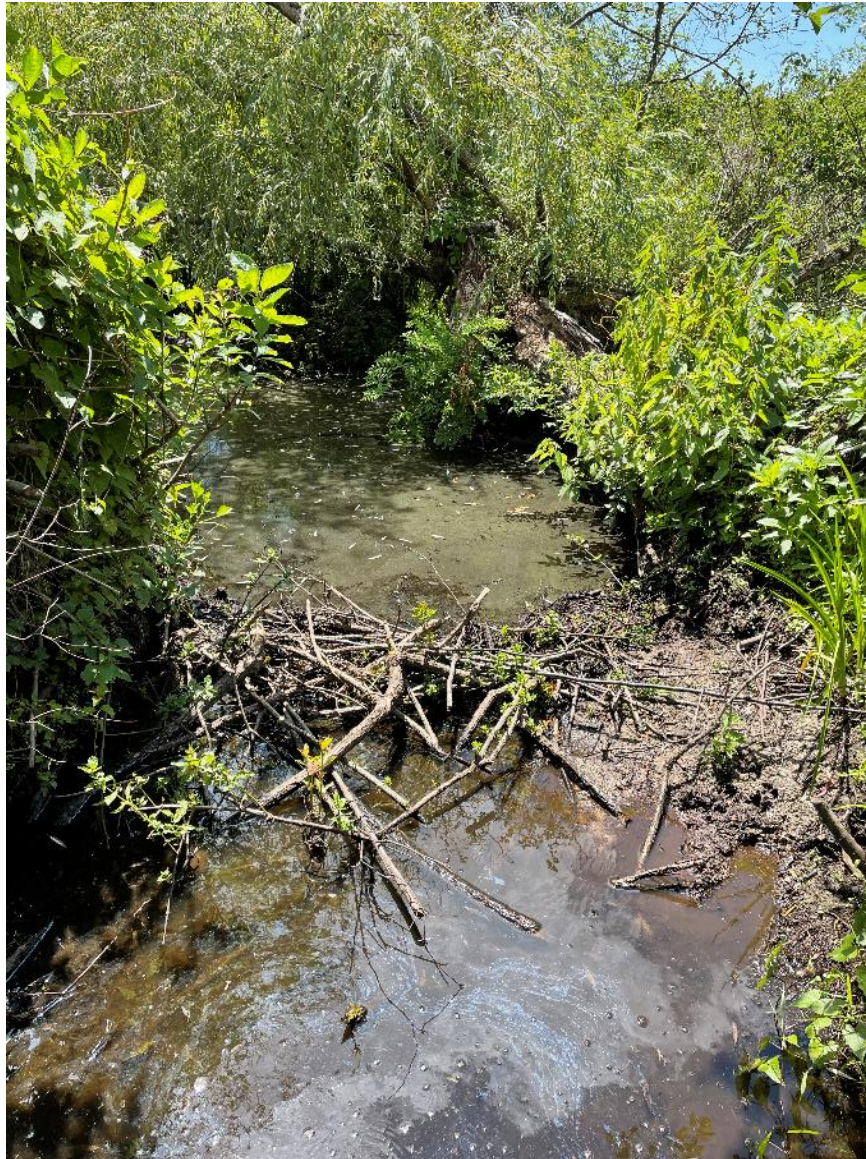
Figure 13. Small beaver dam observed on July 7, 2022

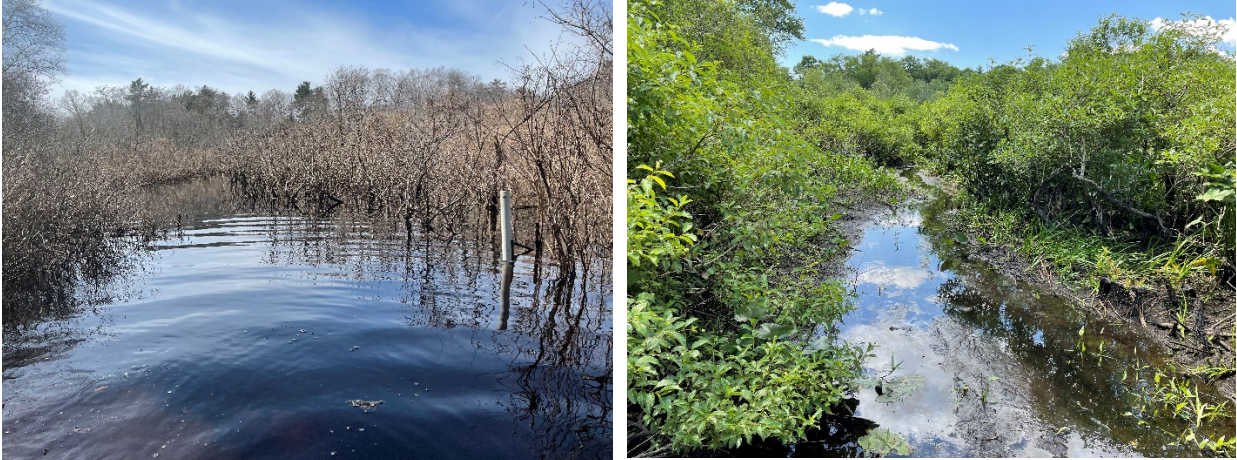
Figure 14. Looking upstream near Logger 3 on March 23, 2022 (left) and July 7, 2022 (right)

At the time of the July site visit, the wetted channel had shrunk from spanning nearly 125 feet across the floodplain, to a 1.5-foot-wide single-thread stream channel (Figure 14). In the upper portion of the reach, flow appeared to be sufficient to support fish passage, but it was increasingly marginal in the downstream end of the reach where flow was diminishing. At the downstream end of the reach, the surface flow had disappeared, leaving a dry riverbed downstream through the Pond Street bridge (Figure 15 and Figure 16).

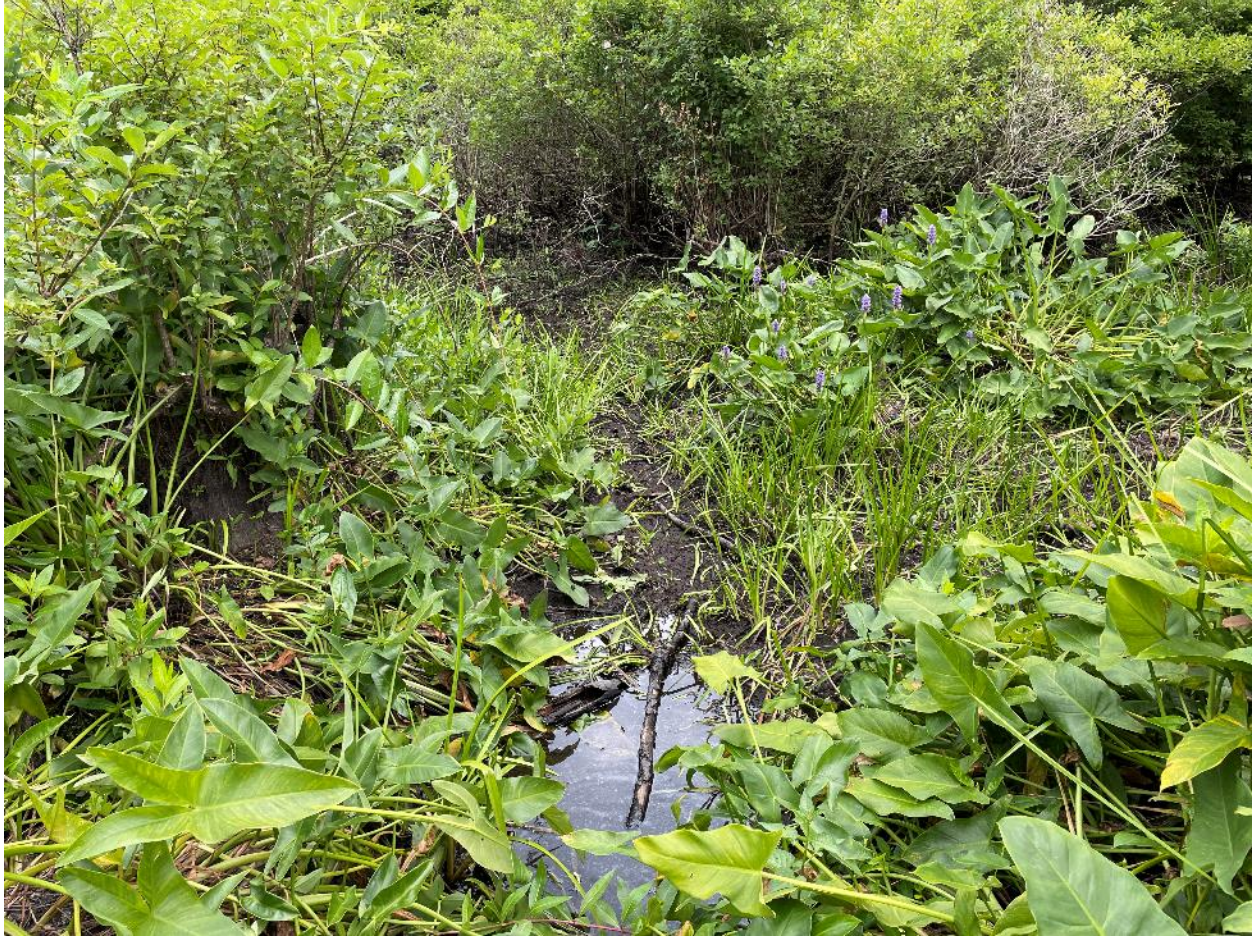
Figure 15. Looking downstream near the break between the Middle and Lower Reach. The dry channel bed is visible beyond the surface water in the foreground. Photo taken July 7, 2022.

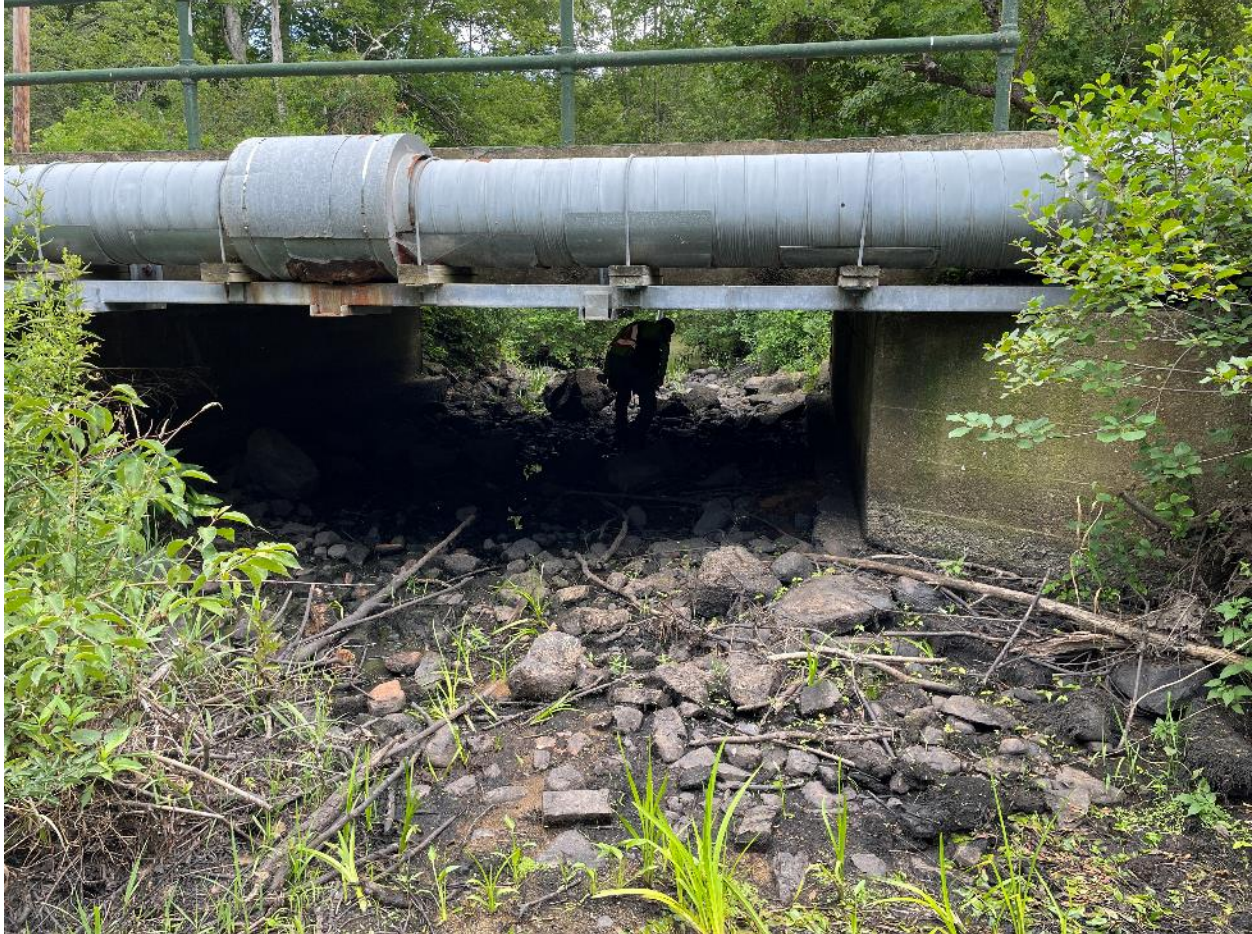
The Lower Reach ends approximately 150 feet downstream of the Pond Street bridge. Substantial rock appears to have been added to the channel to act as a grade control to protect the bridge. No apparent fish passage barriers were observed in this reach. At the time of the July site visit, however, the stream was completely dry, with no surface flow observed (Figure 16). A landowner adjacent to the stream remarked that it was not atypical for the streambed to be dry in the summer.

Figure 16. The Pond Street crossing on July 7, 2022. No flow was present in the channel.

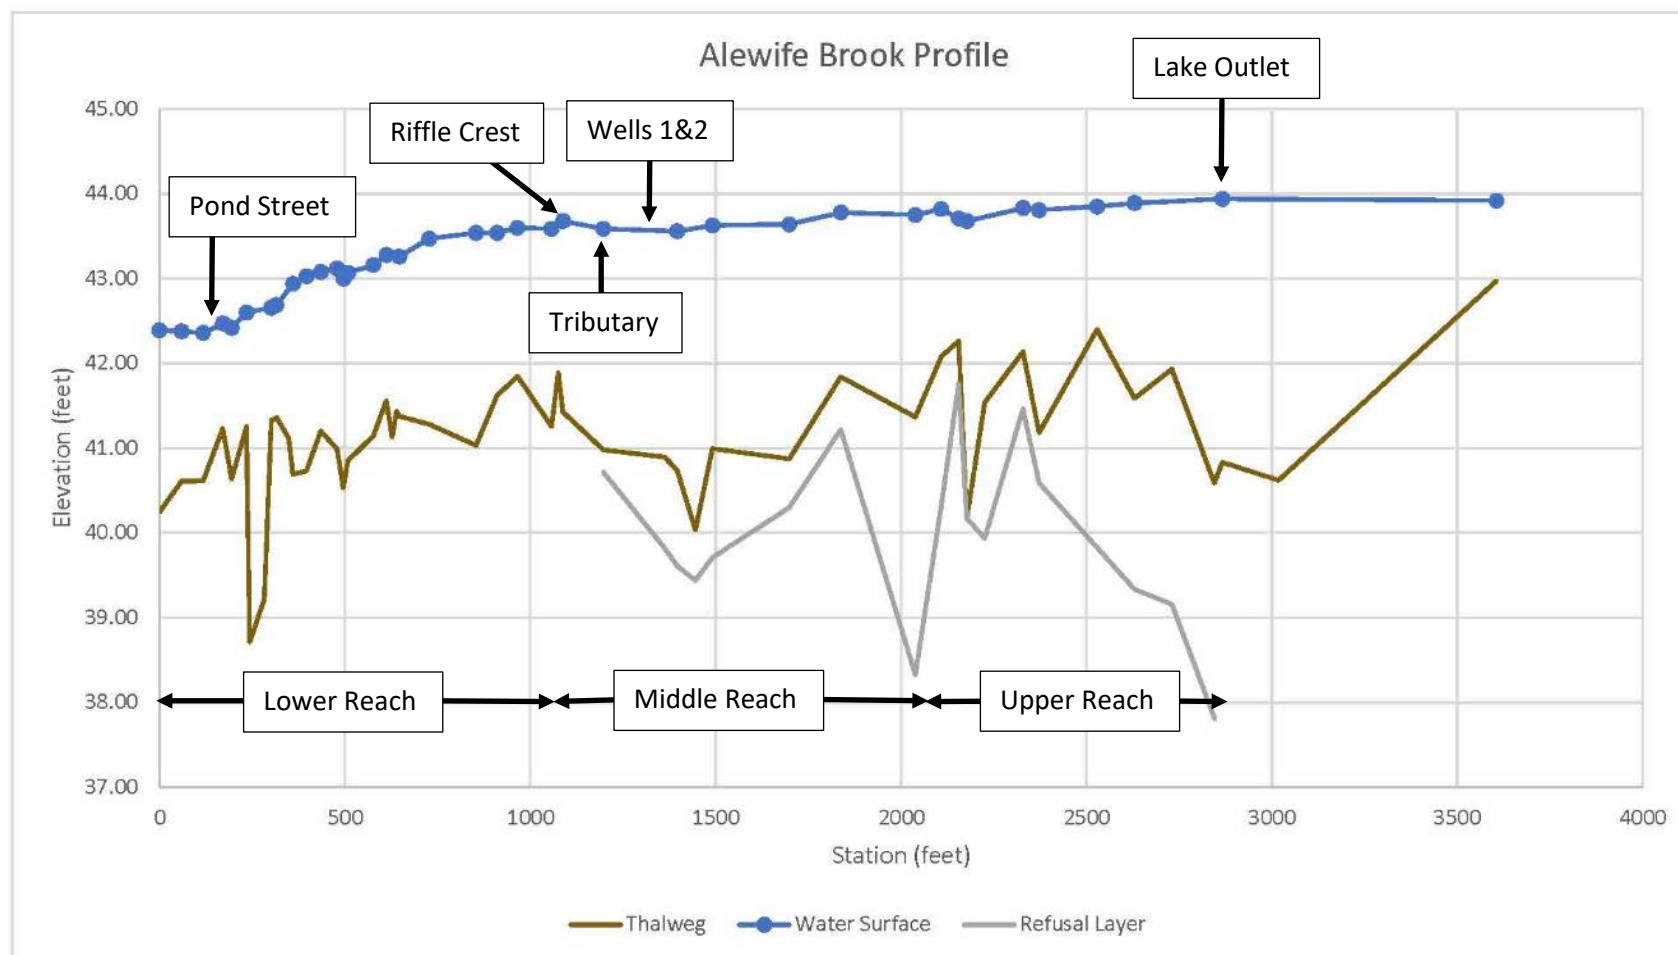
Figure 17. Alewife Brook profile through the study area. Data collected on March 23, 2022. Accumulated sediment is indicated by the difference between the gray 'Refusal Layer' and the brown 'Thalweg'.

The survey data indicate that the channel gradient is relatively flat through the Upper and Middle Reaches. Flow through this area was diffuse during the March and April site visits, though it became increasingly concentrated with downstream distance. Along these reaches, measurable (0.3 to 3.0 feet) fine sediment and organic material had accumulated over the bed surface. The Middle-Lower Reach transition is marked by an increase in slope and coarser bed material, with no accumulated fine sediment present on the bed.

During the March site visit, Inter-Fluve conducted a topographic survey using a Real Time Kinematic GPS system. The survey data were used to construct a longitudinal profile of Alewife Brook through the Study area. The longitudinal profile includes the elevations of the water surface, the channel bed, and the underlying refusal layer in areas where the channel bed was covered with soft fine sediment and organic material. The results of the survey are shown in Figure 17.

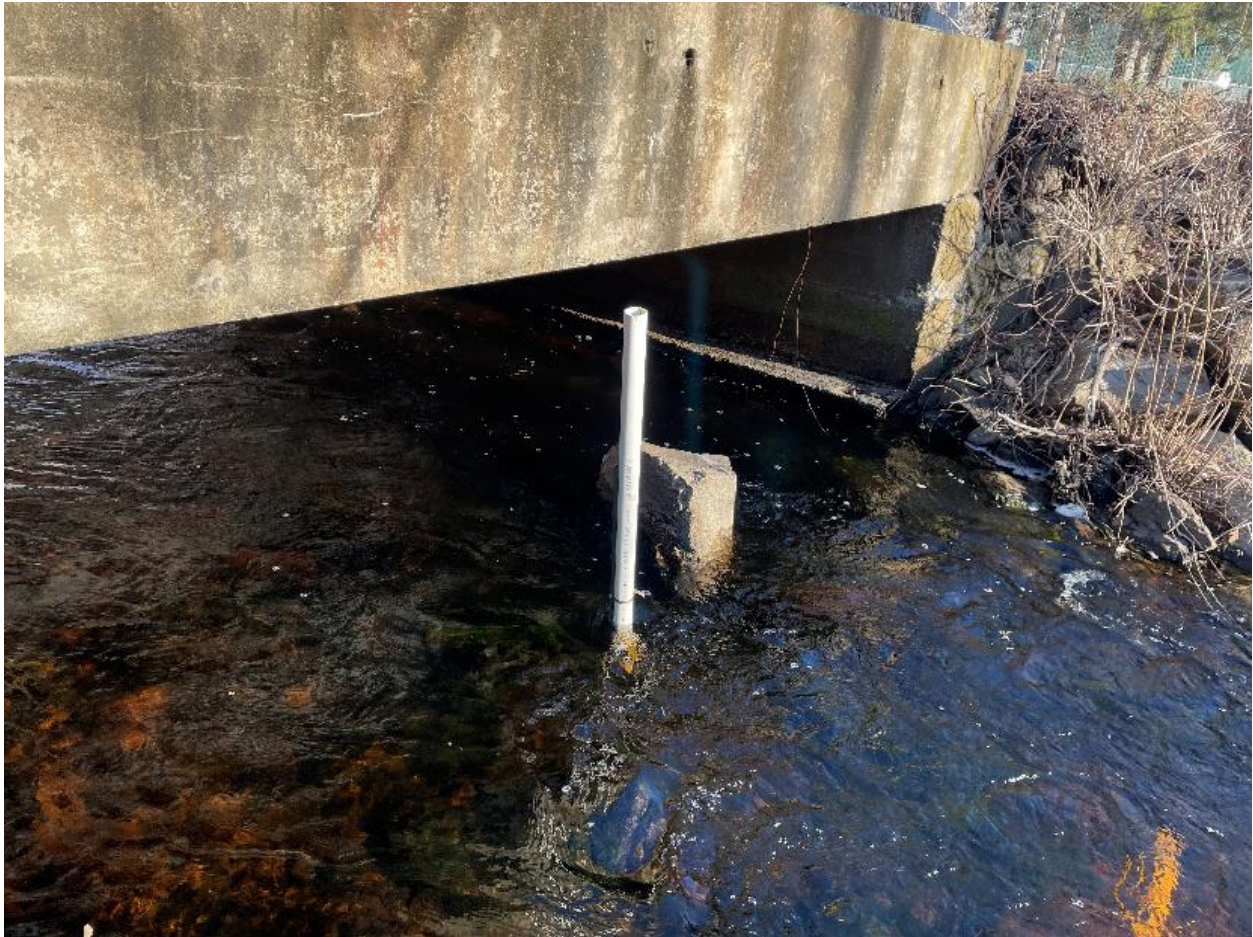
Figure 19. Water level monitoring well at the Pond Street crossing (Photo date: March 23, 2022).
